CASE HISTORY HONDA CIVIC

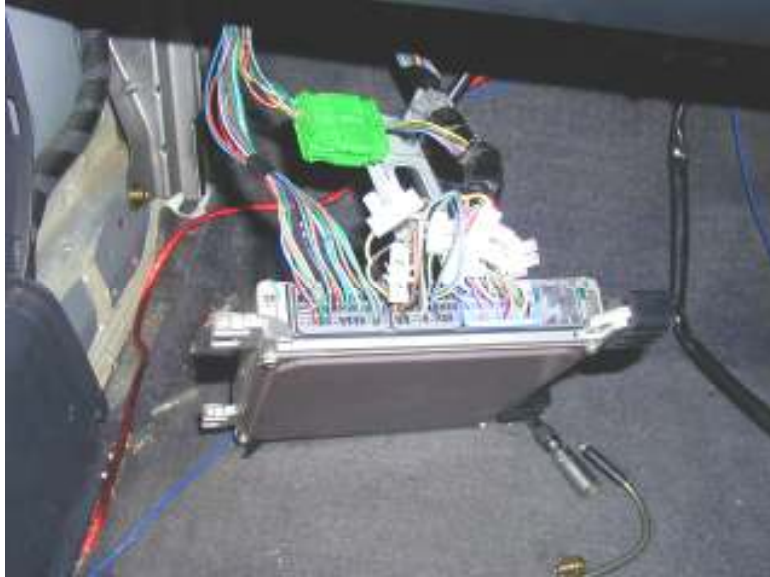
Below is a picture of the main engine management E.C.U on a Honda civic as it was presented to us to fit an Apexi v-Tec controller. From the picture it can be seen that previous wiring attempts to install the unit were aborted and a very poor standard of rejoining the wiring loom had been made using chocolate blocks and twisted wires.

After repairing the wiring by soldering and insulating with heat shrink we were able to install the controller and be sure of a quality job with long term reliability.
